RANGE RESOURCES

June 3, 2009

Subject: Incident Report
Range Resources – Appalachia LLC
Cross Creek County Park Well Nos. 14H, 15H, and 16H
Well Permit Nos. 37-125-23165-00, 37-125-23182-00, and 37-125-23300-00
Hopewell Township, Washington County, Pennsylvania

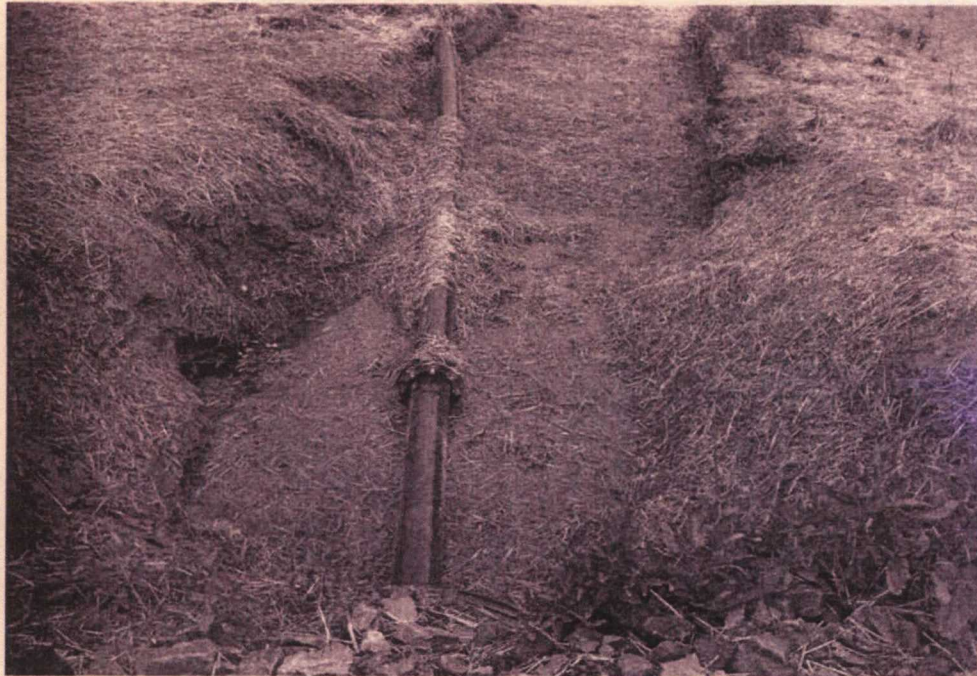
PHOTO #1

Range Resources personnel immediately shut down the flowback operation when the leak of flowback water was discovered. Upon further investigation, Range Resources personnel determined that the water had leaked from the pipe at the location of 2 of the couplings due to the fact that 3 of the bolts for each of the couplings were loosened. Range Resources was unable to determine how the bolts, all on the underside of the couplings, were loosened. Due to the loose bolts, the water leaked, pooled in a low spot of the existing ground surface at the location of the leak, and then flowed via overland flow into an unnamed tributary to Cross Creek. When Range Resources personnel had assessed the situation, DEP personnel were then notified via telephone at approximately 5:15 pm. The attached photographs show the location of the leak.

Coupling where loose bolts were found and leak occurred. Picture was taken after clean-up and water in low spot at pipe is fresh water.

In the future, the use of bolted flanged couplings will be minimized or eliminated on piping being used to convey flowback water. Additionally, line inspections will be performed more frequently, especially at bolted flanged connections. When pumping is ceased between stages of water conveyance, all flanged connection integrity will be verified. If required, the connections will be tightened prior to commencement of pumping water through the piping for the next stage. Finally, if possible, spill containment kits will be located along the line where there are bolted connections.

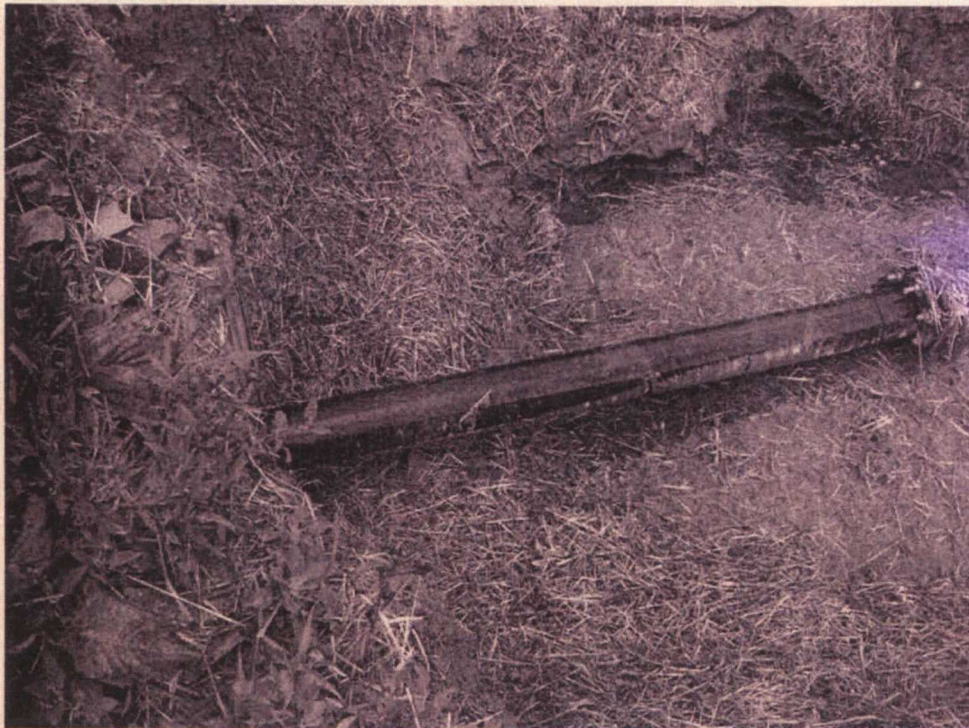
PHOTO #2

Coupling where loose bolts were found and leak occurred. Picture was taken after clean-up and water in low spot at pipe is fresh water.

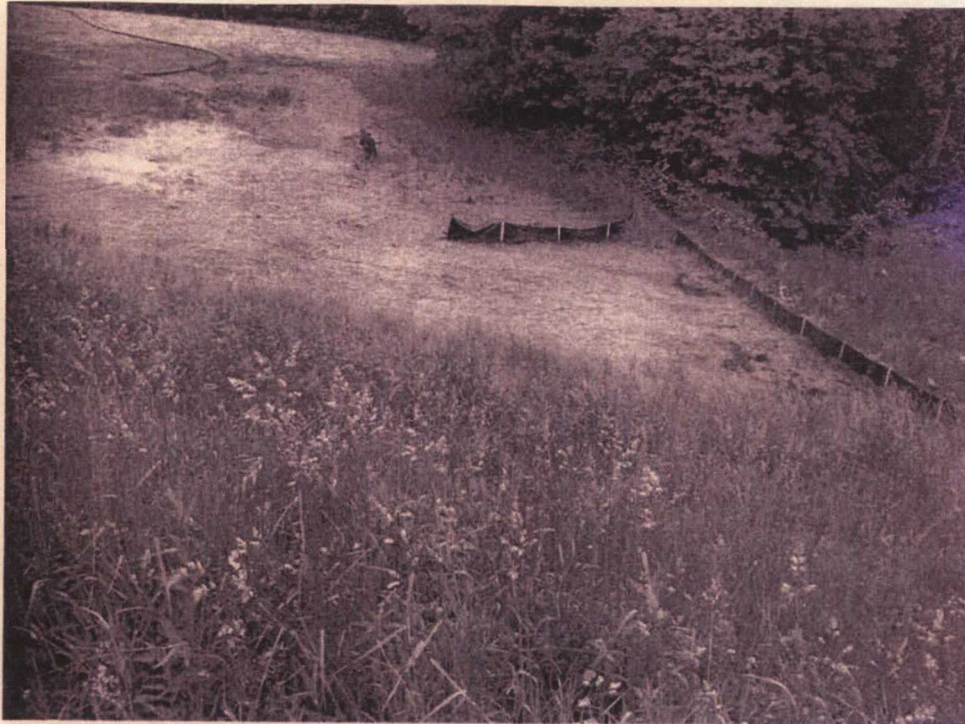
PHOTO #3

Down slope area affected by spill following clean-up and seeding and mulching

Flowback water that was contained by the check dams installed in the unnamed tributary was pumped out by a vacuum truck in locations that were accessible. Additionally, any soil affected by the spill of flowback water was excavated from the area and placed in three lined dumpsters on site. Sampling and analysis of the soil in the dumpsters will be performed to determine the final disposition of the soil. The entire area of disturbance was immediately seeded and mulched. The attached photographs show the area following soil removal and seeding and mulching.

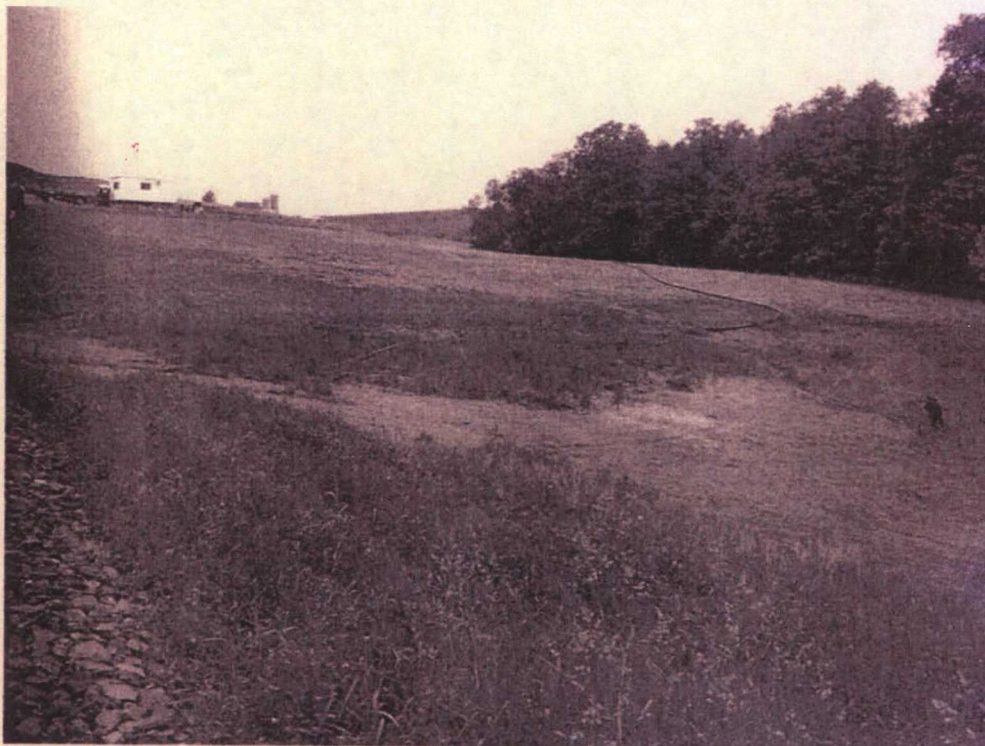
PHOTO #4

Down slope area affected by spill following clean-up and seeding and mulching
